# Situation Photo Log

Thursday, December 13, 2012

Kalamazoo River / Enbridge Spill

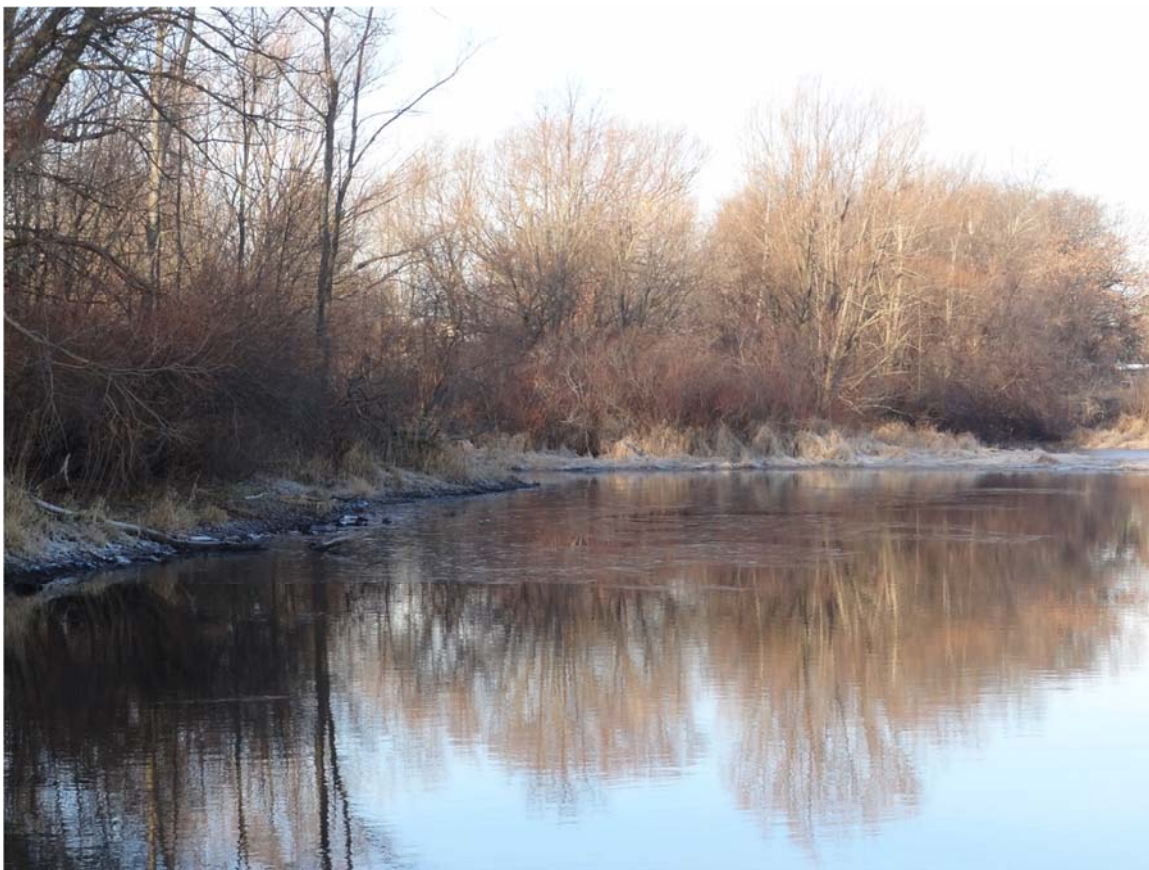
1. MP5.60 LDB ice observed forming.

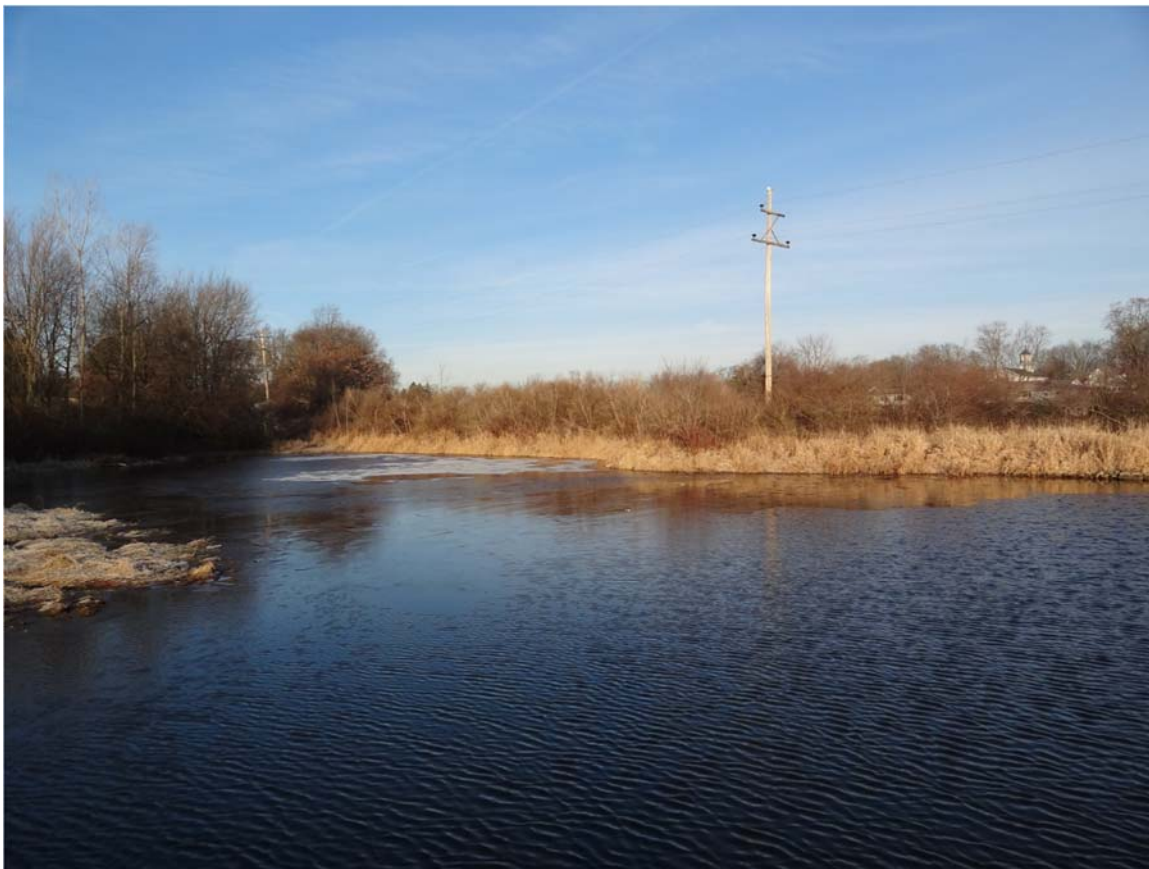
2. MP5.63 LDB ice observed forming above the railroad trestles.

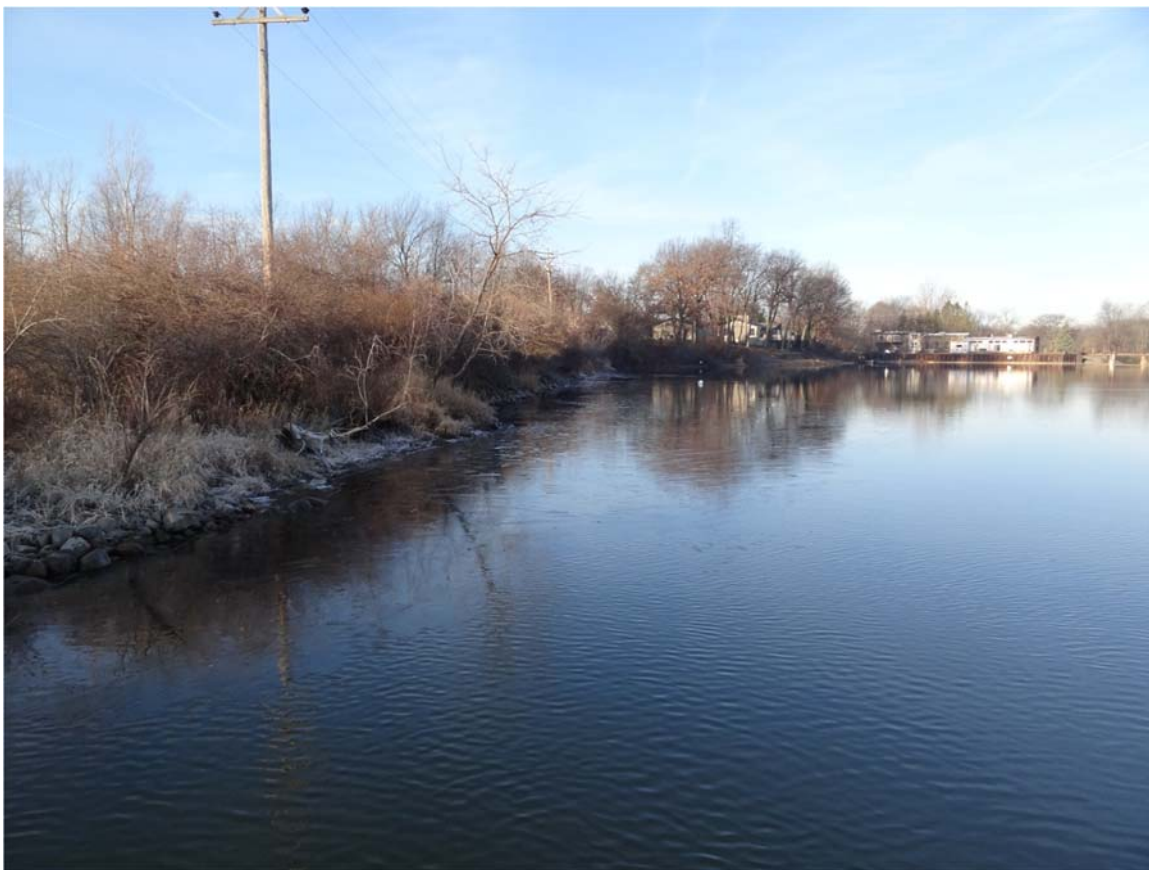
3. MP5.63 LDB ice observed forming below the railroad trestles.

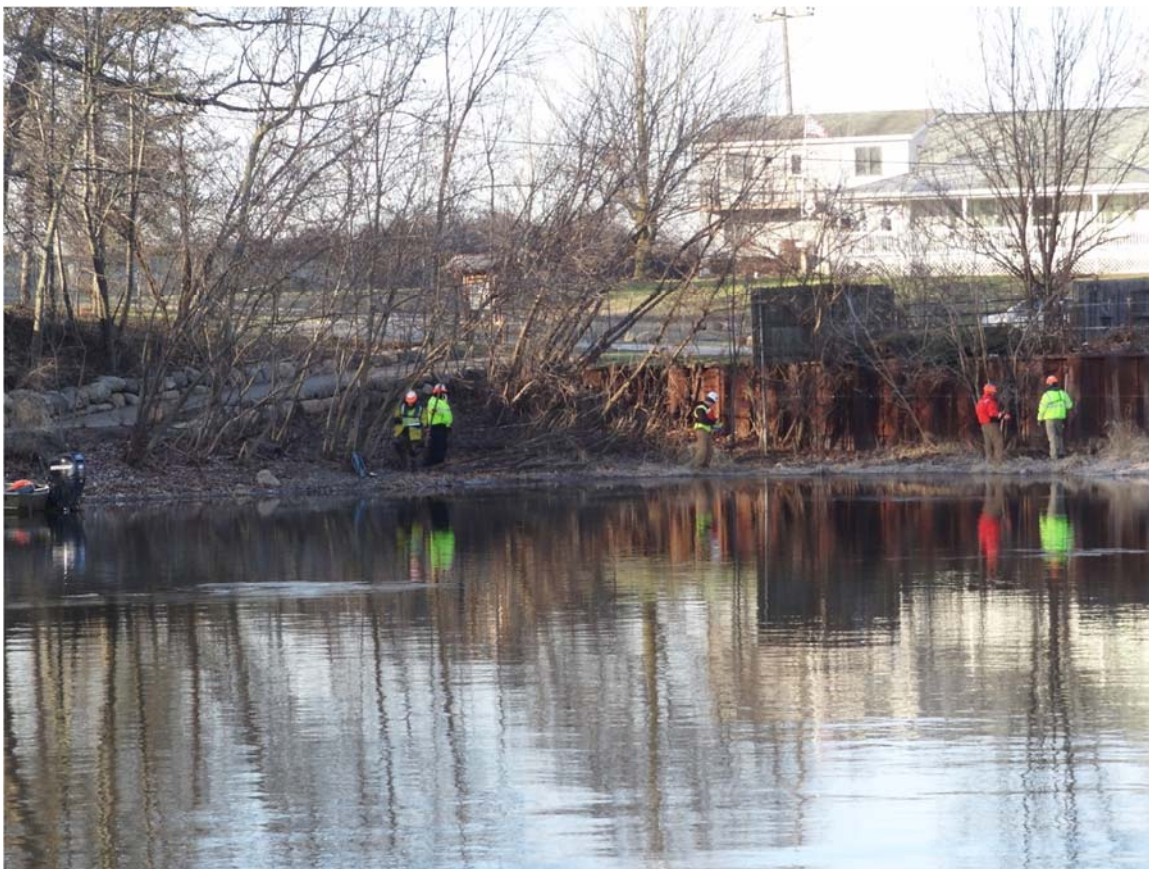
4. Ceresco Dam impoundment observed a bathymetry team.

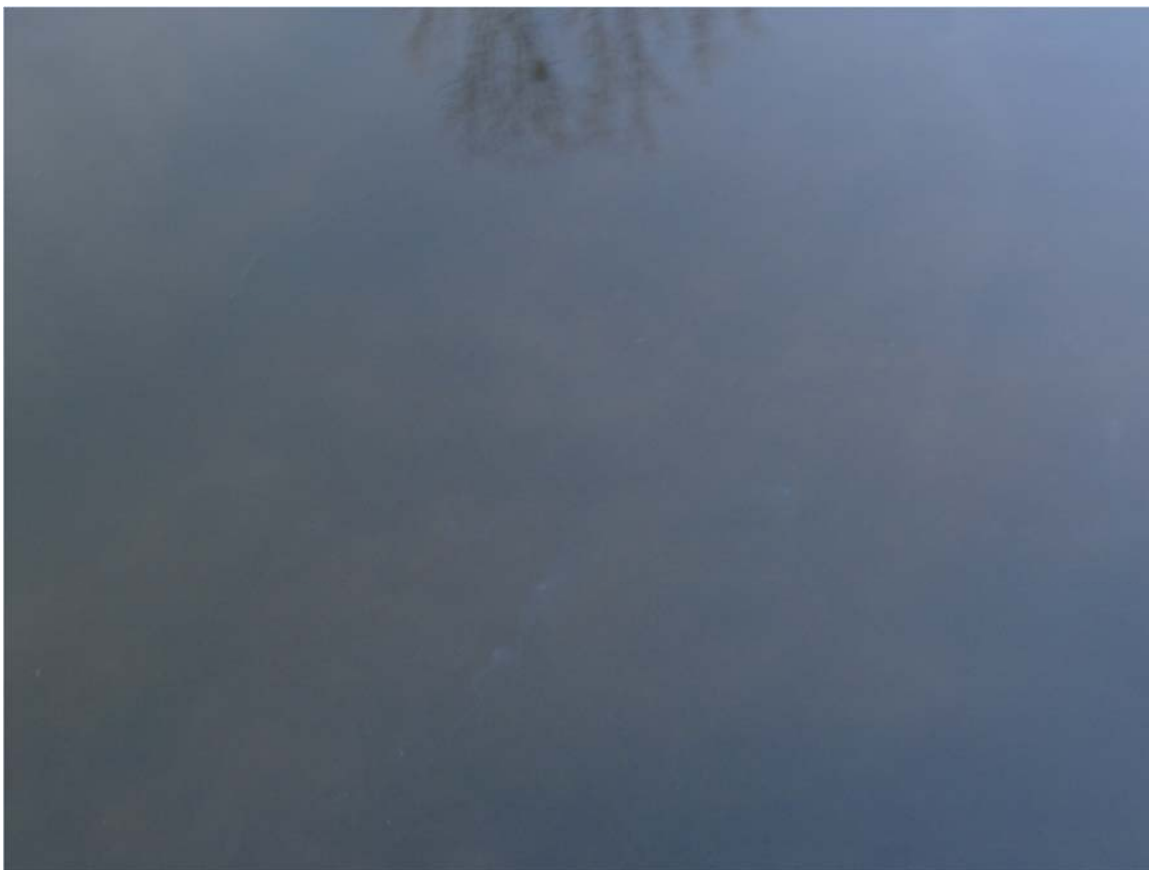
5. Just above the Ceresco Dam sheen observed along the LDB.

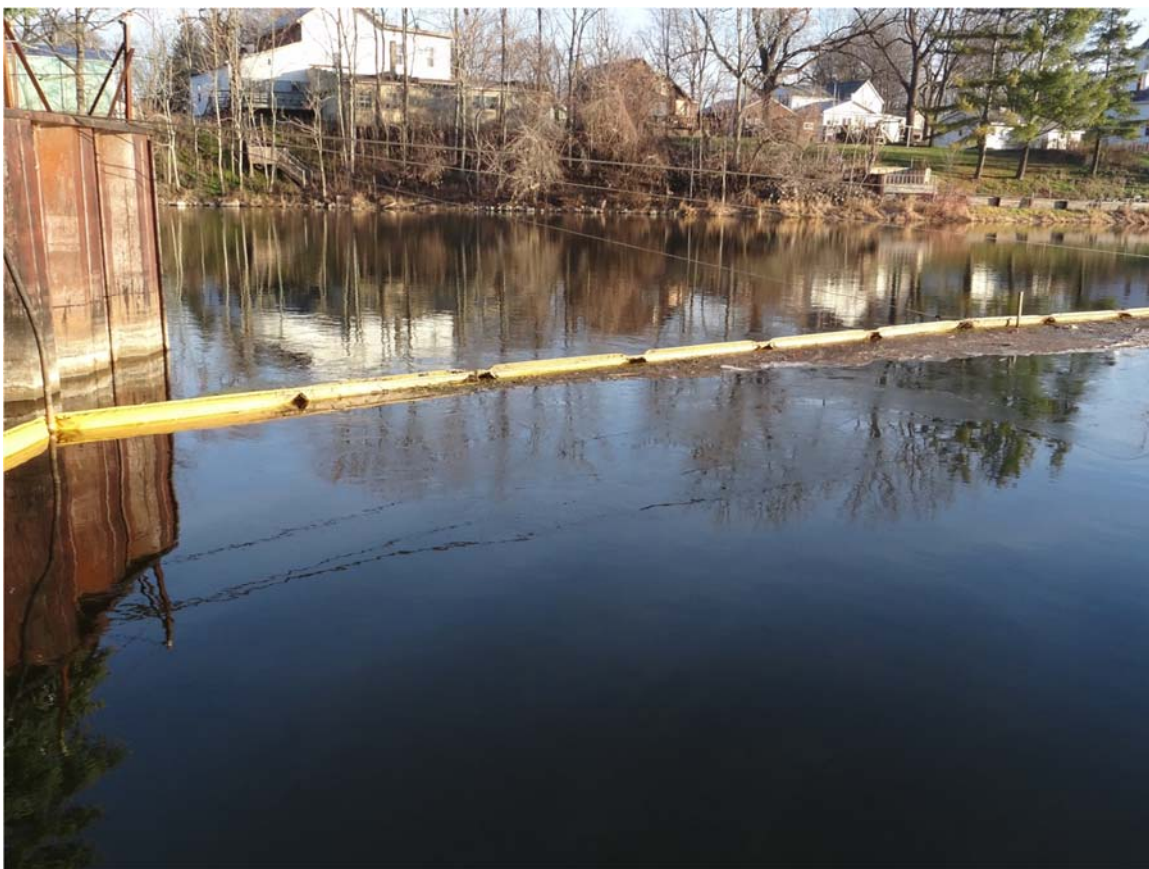
6. Ceresco Dam control point boom observed a very thin layer of ice forming.

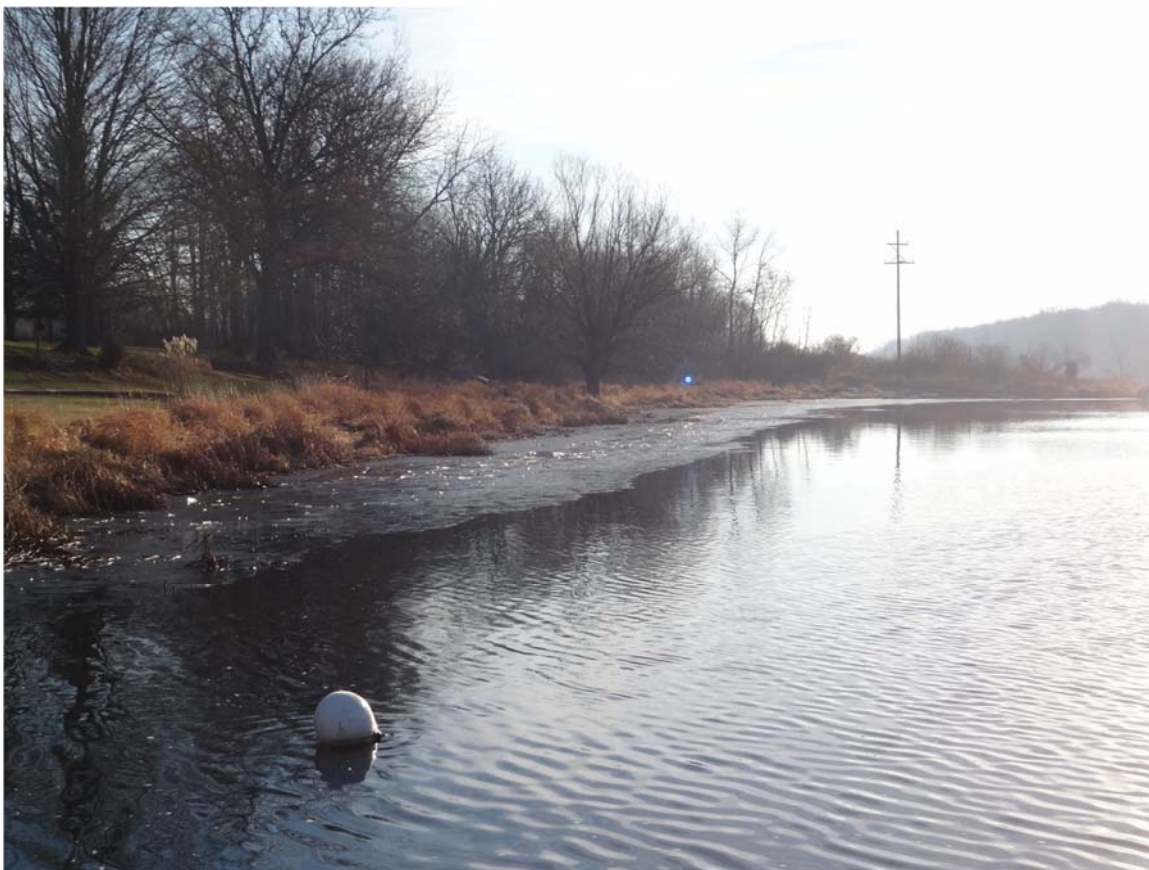
7. MP5.63 – MP5.70 RDB observed ice forming.

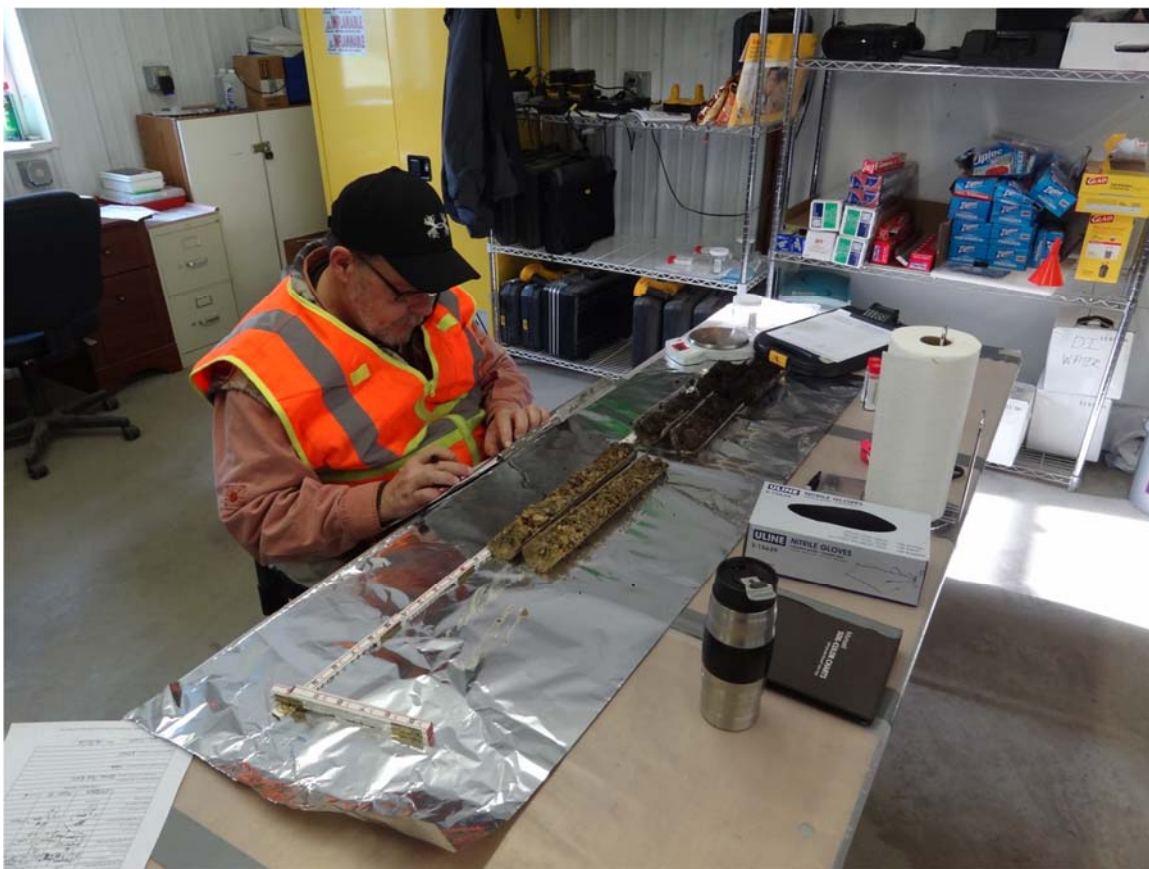
8. Observed core logging at the C3.2 building.

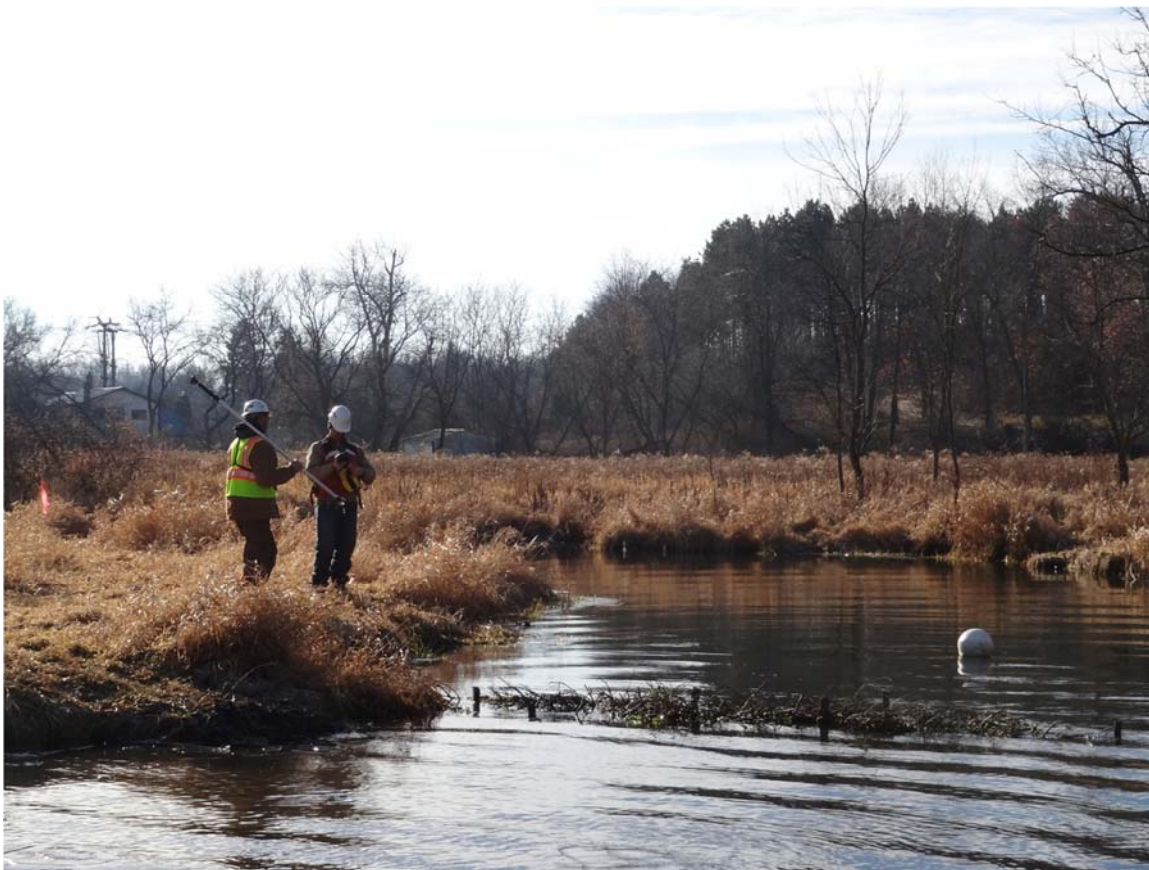
9. MP10.75 LDB Sediemtn trap observed a bathymetry team.

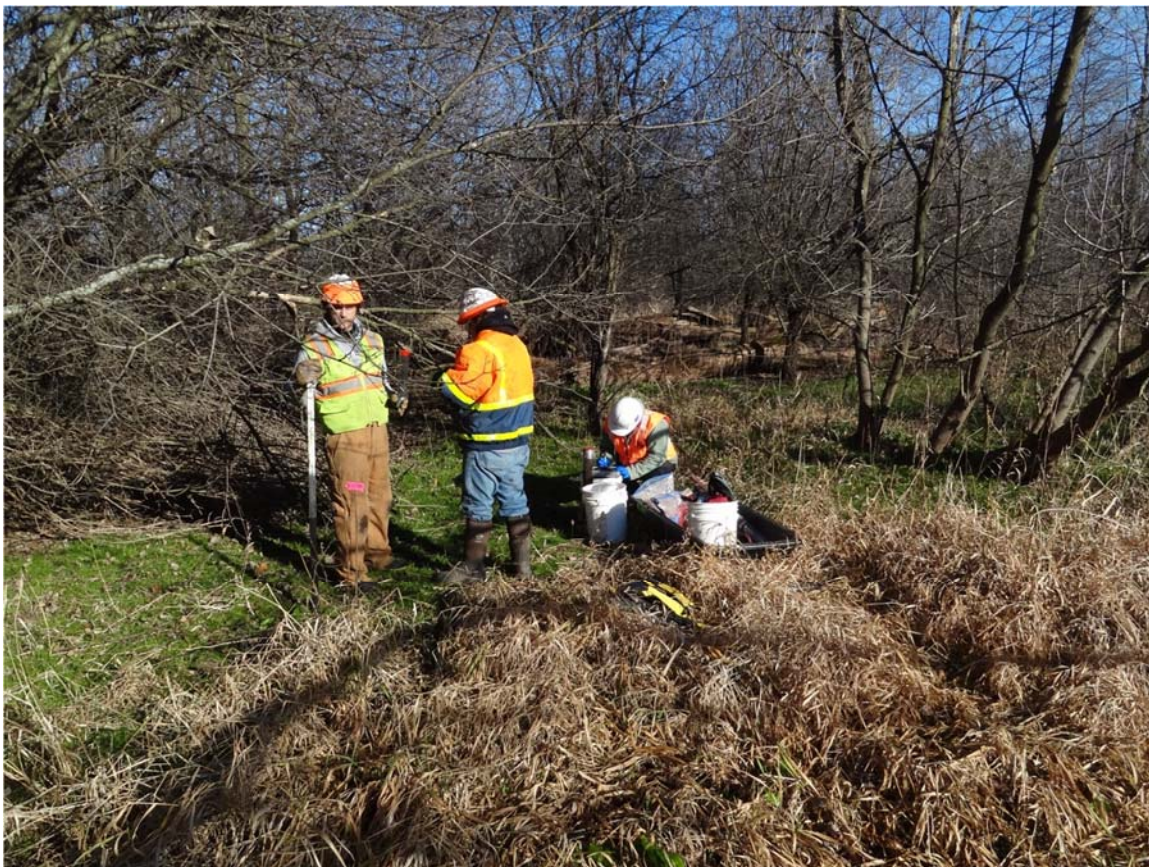
10. MP12.5 RDB observed an RI crew.

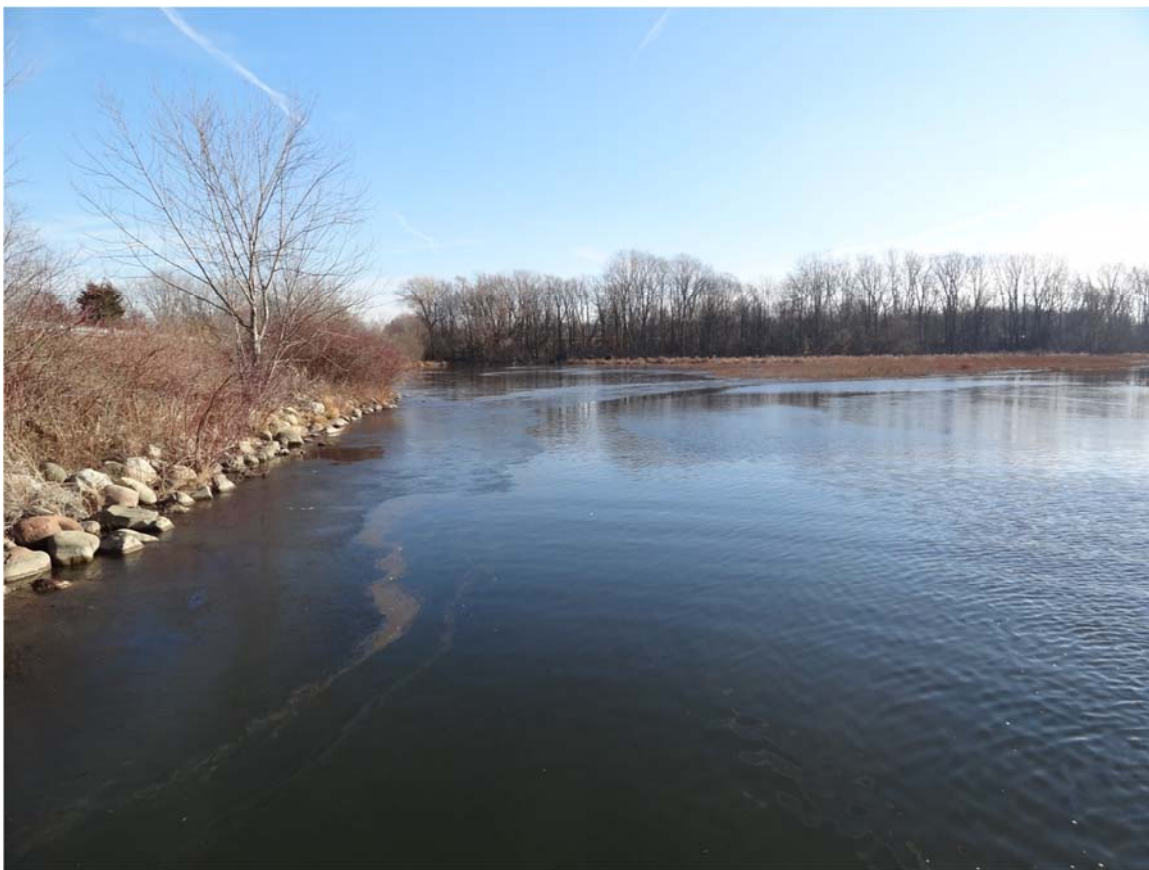
11. MP15.25 South Mill Pond observed ice forming.

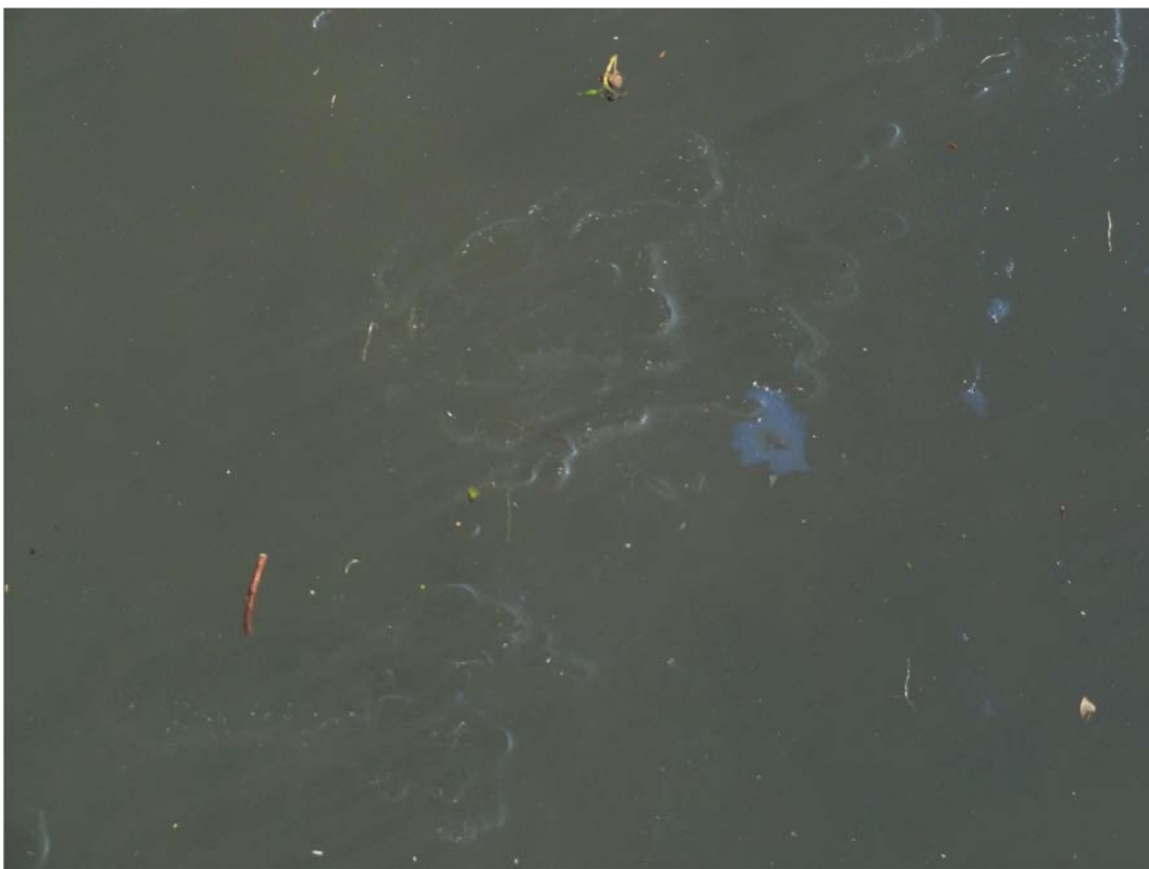
12. MP15.25 South Mill Pond observed sheen and tar globs frozen in the ice.

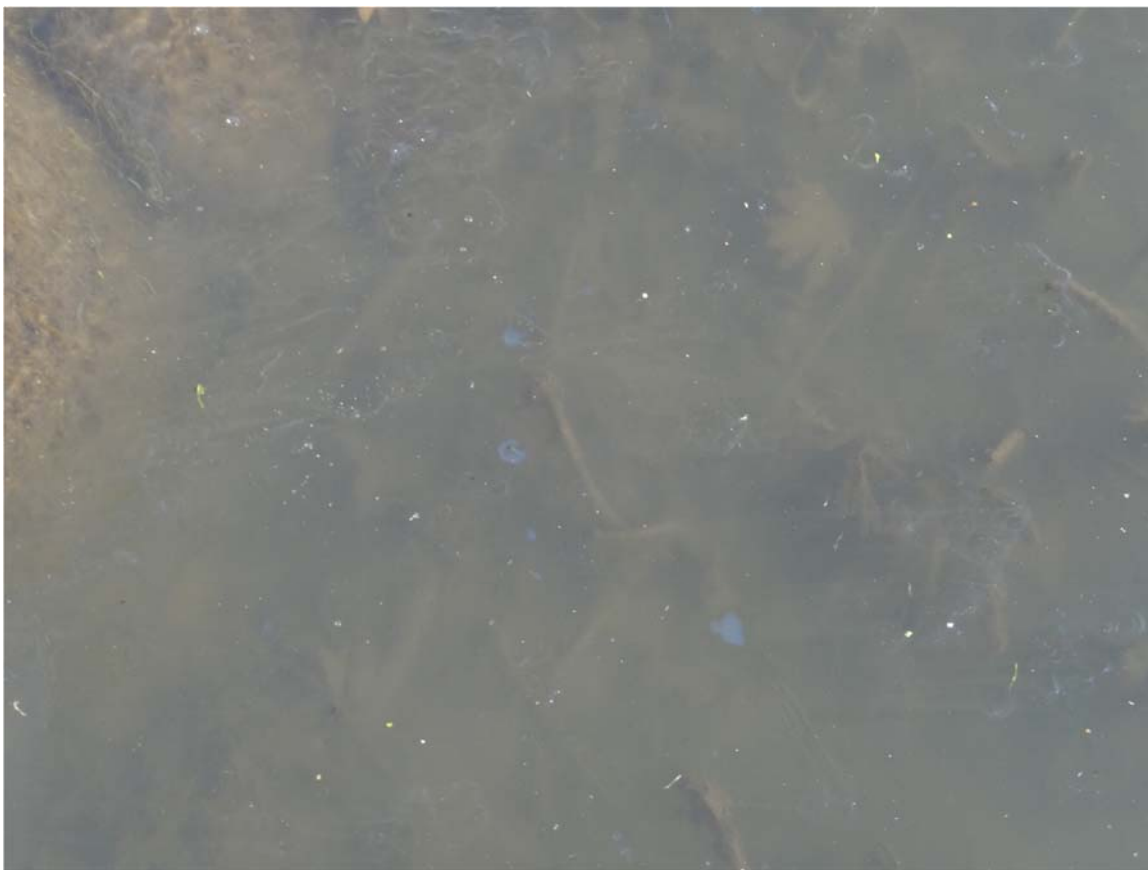
13. MP15.25 South Mill Pond observed sheen and tar globs frozen in the ice.

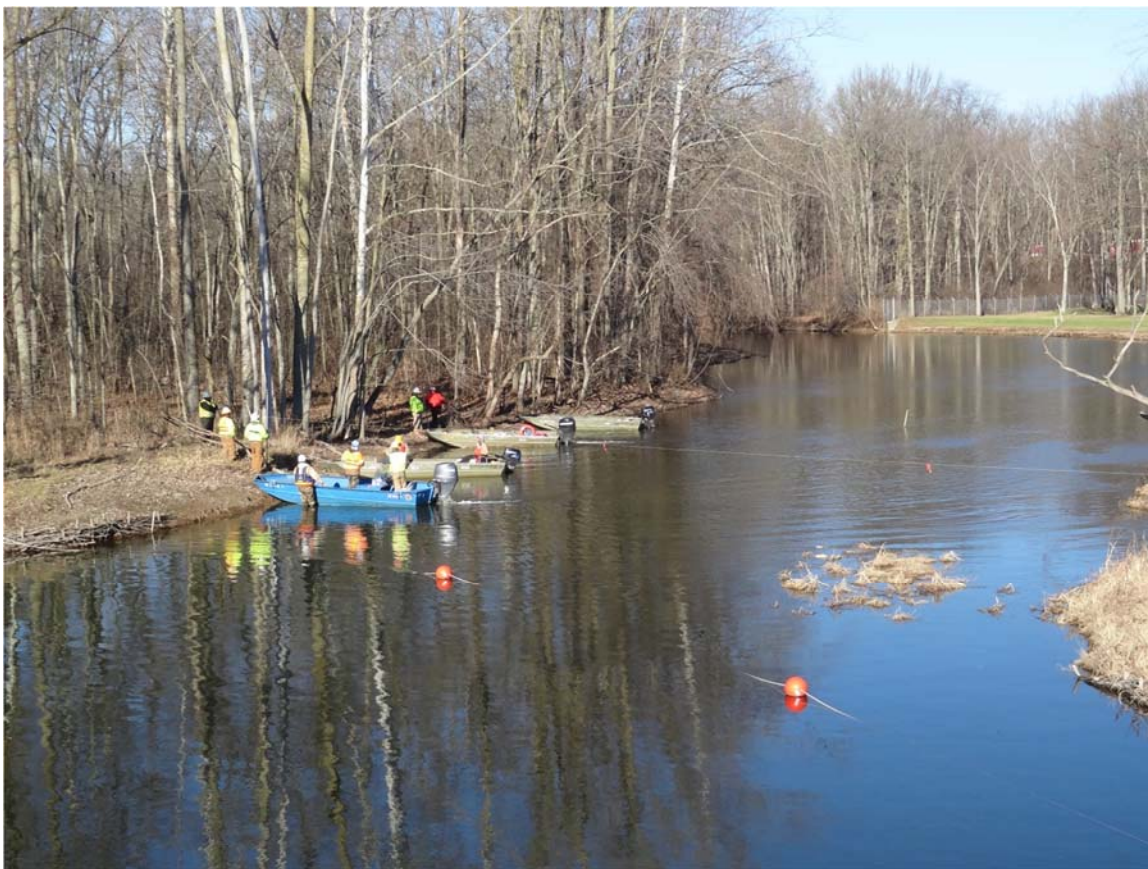
14. MP21.5 Sediment trap observed a bathymetry team.

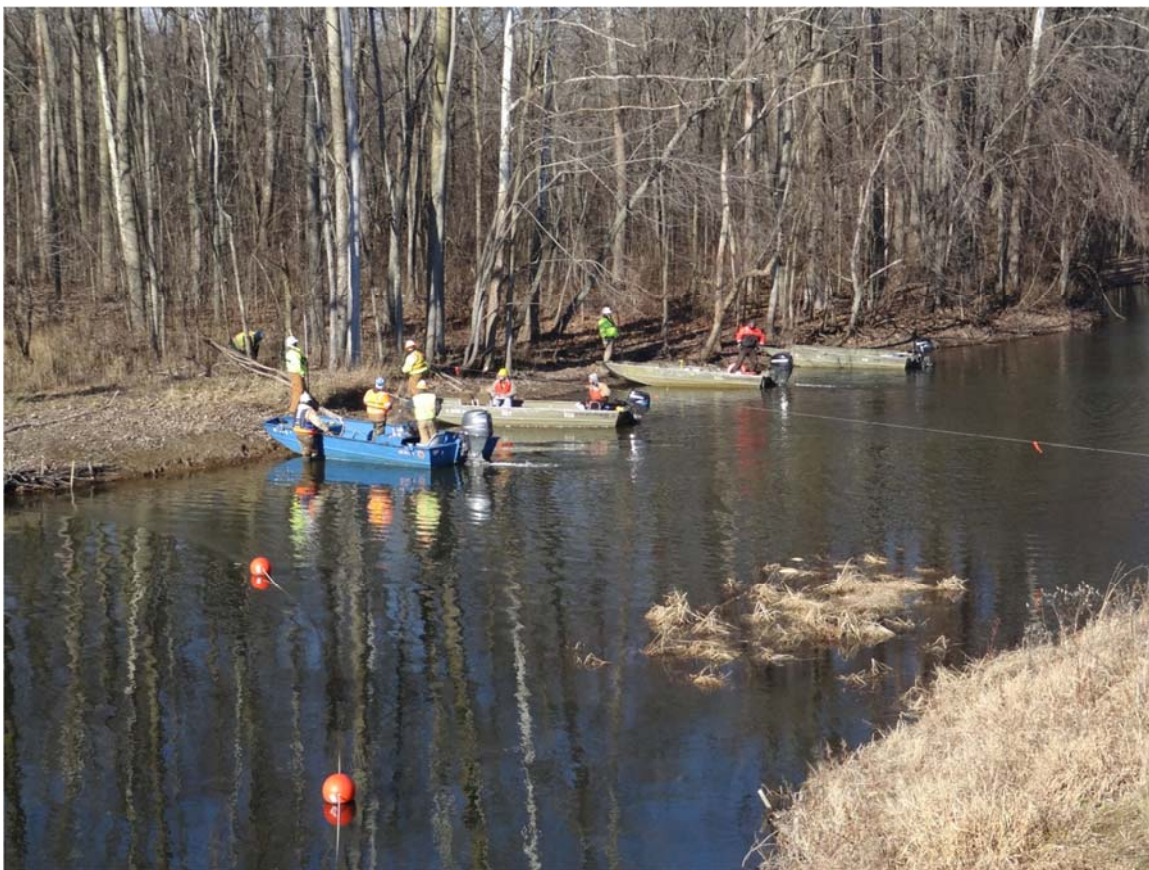
15. MP21.5 Sediment trap observed a bathymetry team.

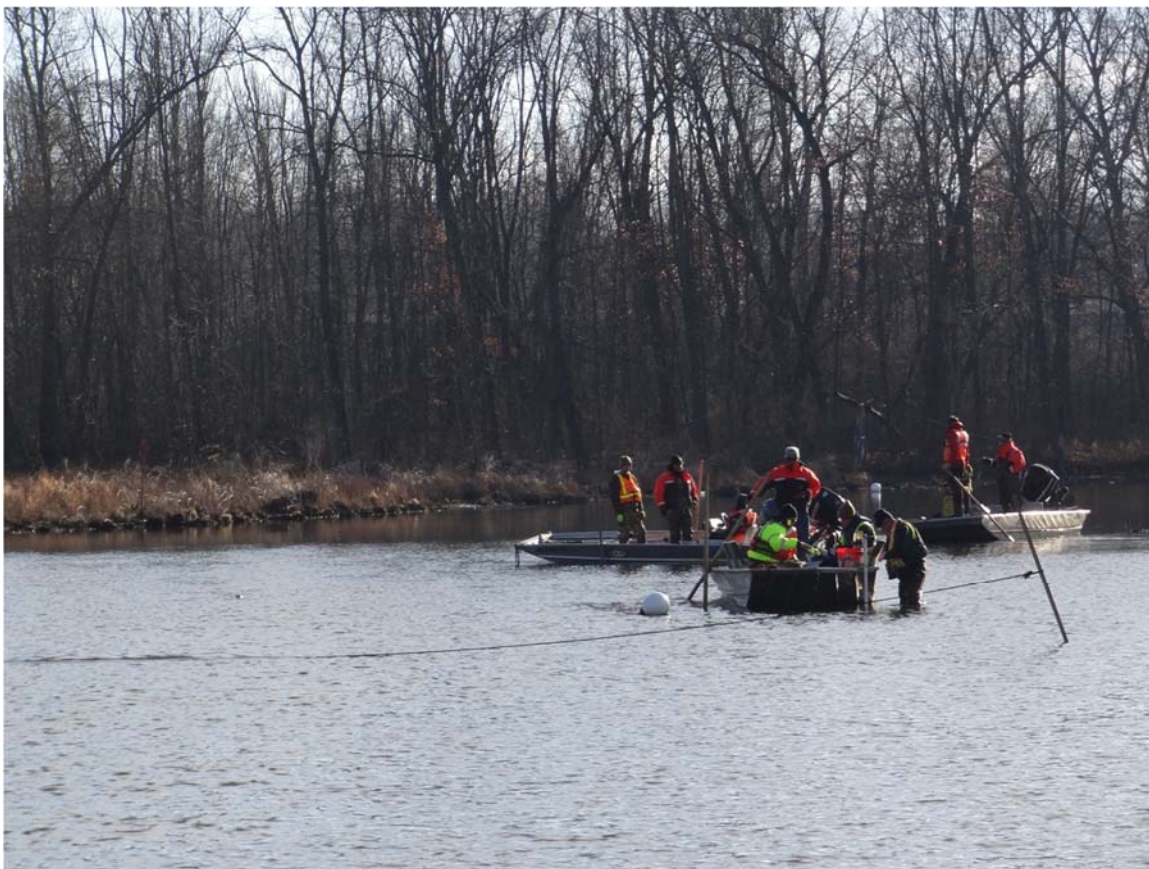
16. Morrow Lake Delta A observed a bathymetry team and a CSD sampling team.

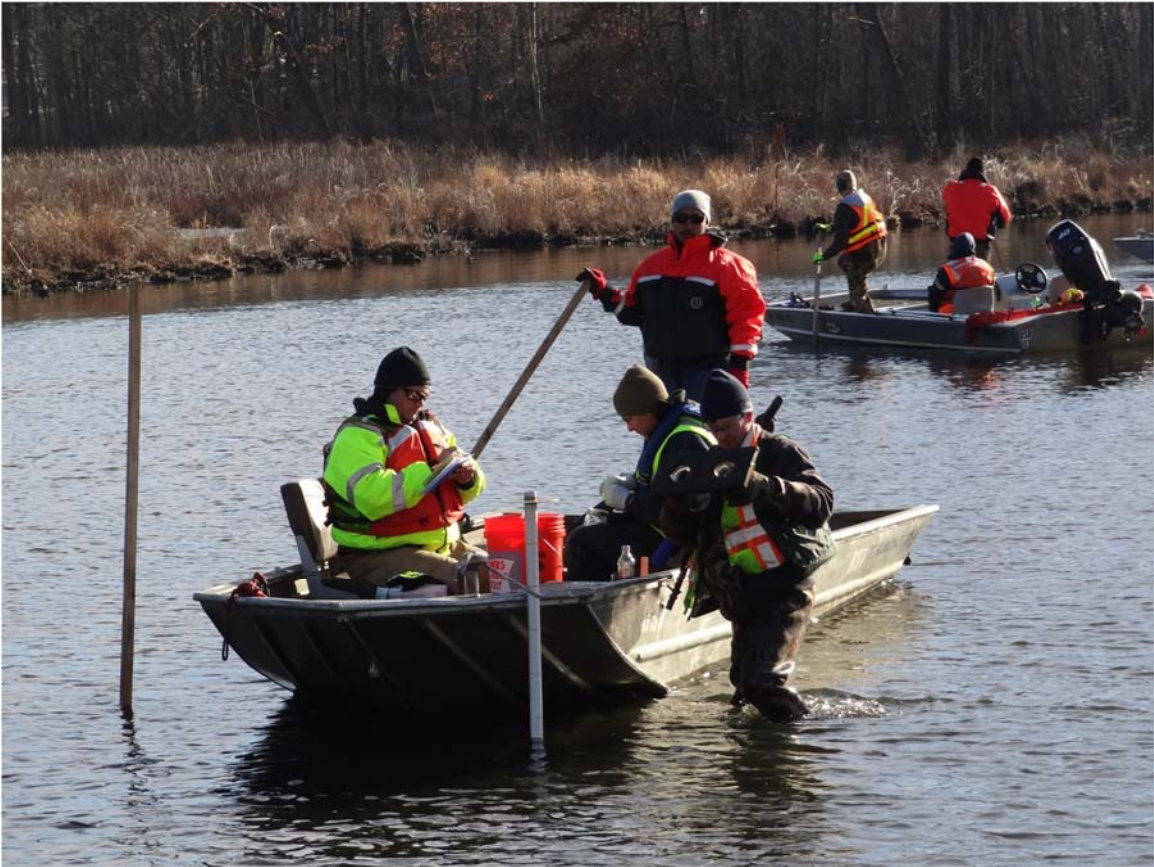
17. Morrow Lake Delta A observed a CSD sampling team.

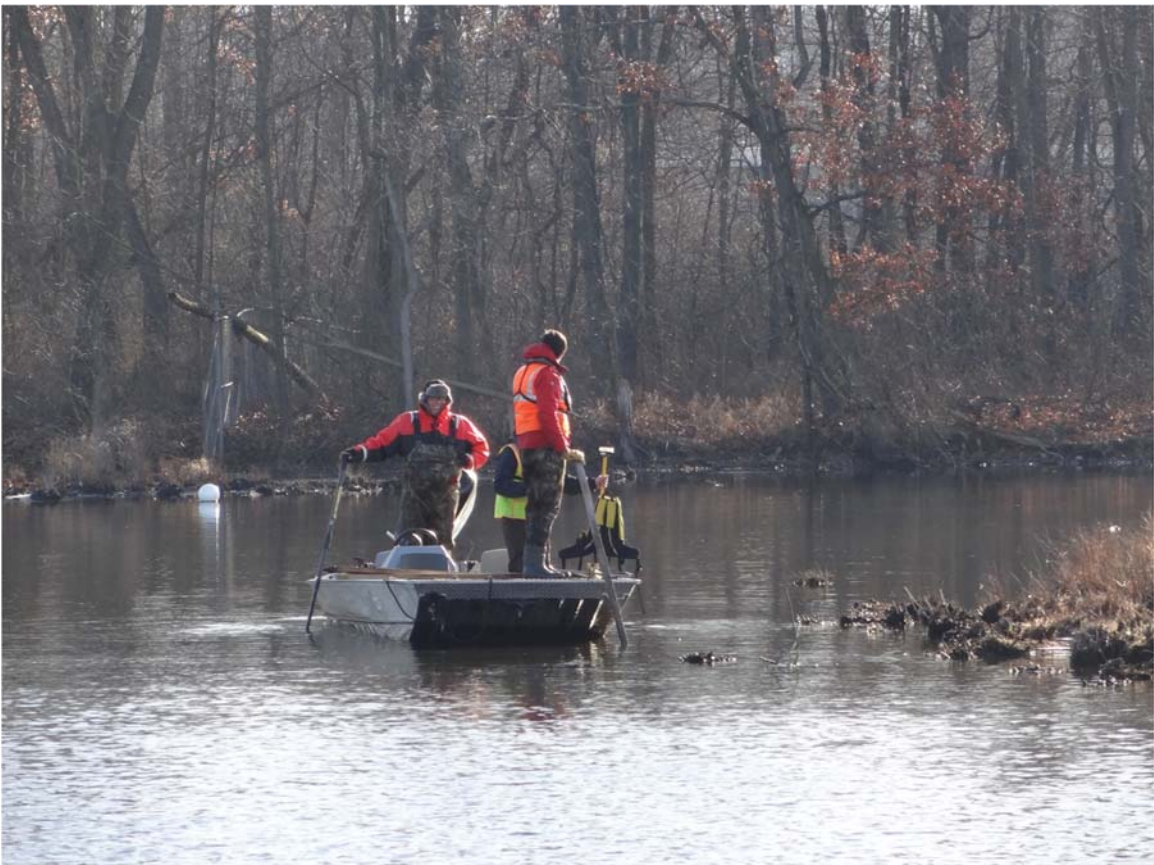
18. Morrow Lake Delta A observed a bathymetry team.
